## **ACHIEVEMENTS OF ELECTRICAL MAINTENANCE WING DURING 2024-25:**

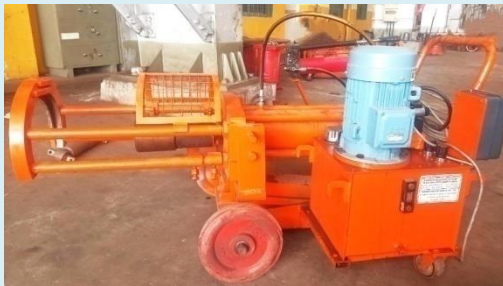
A Motorised Hydraulic press machine for mounting and dismounting of plane & lipped CRU-150 type bearing Racer of WAG9 loco has been commissioned during Apr'24. This system is procured from M/s Sumanglam Equipments Pvt. Ltd.

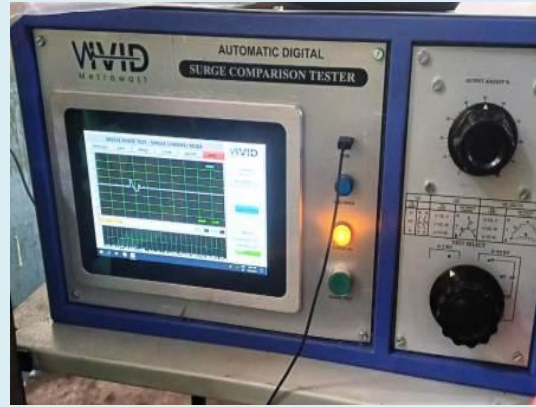
17. **Installation of Automatic Digital Surge Comparison Tester by ELS/SRCE:**

An Automatic Digital Surge Comparison Tester (Model: VM1001) was supplied by M/s. Vivid Metrawatt - Vasai East against P.O. No. IG226519100659 Dated 04.07.2023 and was installed at ELS/SRC. This test unit along with accessories has been commissioned on 09.05.2024.

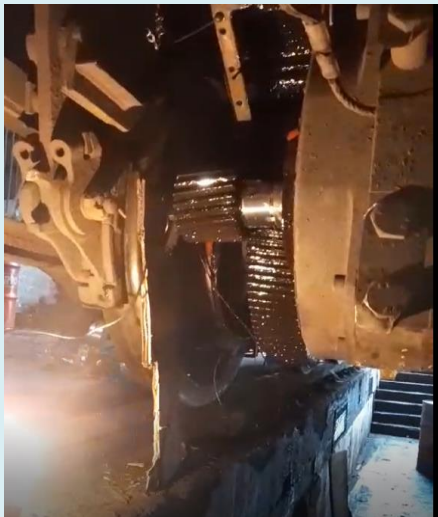
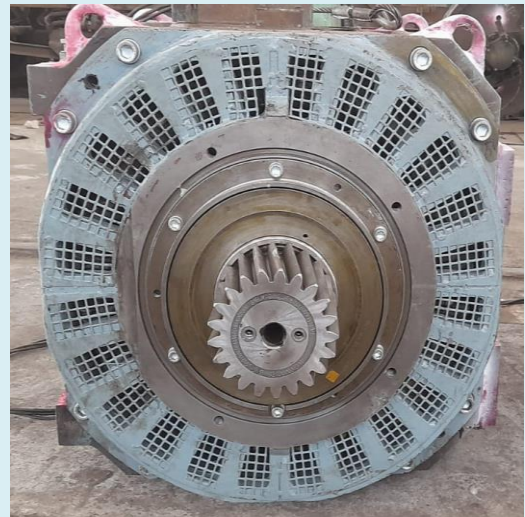
18. **Pinion removing in on position from Traction Motor in Three phase locomotive by ELS/BKSE:**

Pinion removing in on position from Traction Motor in Three phase locomotive has been sussessfully done at BKSE shed during May'24. **This will be useful for pinion removing in breakdown loco on line.** Presently for pinion removing on line pinion is cut by gas cutting, which takes more time and pinion also not used after cutting.

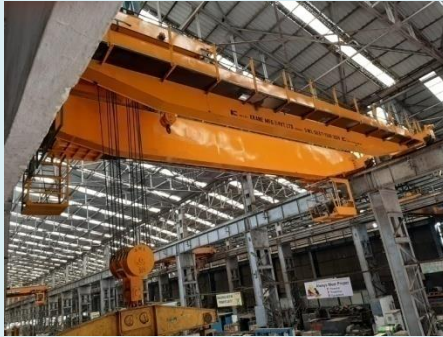
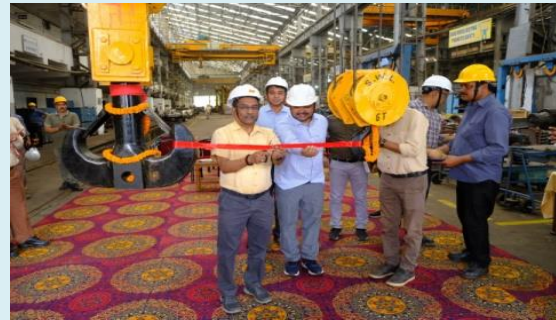
19. **50/06 T EOT CRANE at ELS/BNDL:**

50/6 Ton overhead EOT crane received on 26.02.2024 at BNDL vide COFMOW at no. COFMOW/IR/S/OP-207810 dated 03.05.2020 have been commissioned. Load testing (49T) done on dated 04.05.2024. This will reduce the downtime of locomotives waiting for heavy lifting/lowering as well as replacement of heavy equipment of locomotive thereby improving the availability/outurn of locomotives.

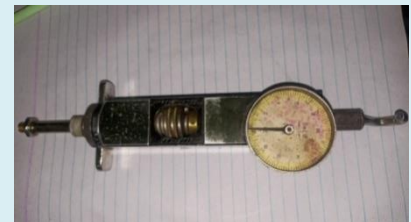
HLC fixed IV coupler power contact pins are getting flashed leading to HLC not working/single phase fault. In case of improper spring tension of IV coupler power contacts.

The contact pressure test is to be conducted on the pins by applying a force on the pins longitudinally and measuring the deflection of compression in the springs. The pressure exerted and deflection thus resulted shall not be more than the values indicated below (As per RDSO SPEC\_0177, Rev-0).

SN	Pressure on the pin	Maximum deflection
1	12 kg	5.0 mm
2	18 kg	7.0 mm

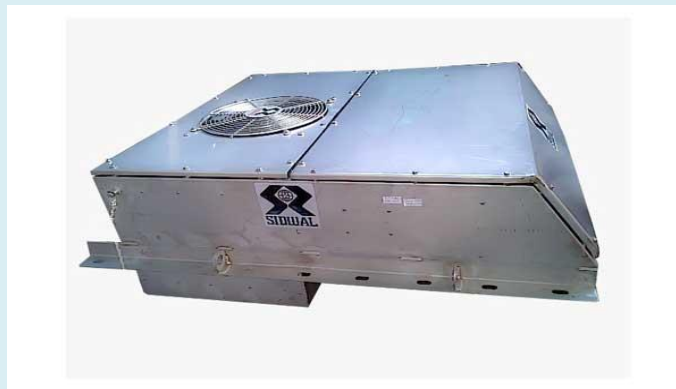
Railways have been advised vide Board's letter No. 2021/Elect(TRS)/138/5, dated: 14.12.2023, to ensure the provision of Cab AC in locomotives during POH schedule. In loco no-22855/WAP4/SRC Cab AC duct was not available so necessary modification in roof has been carried by ERS-POH for making space for Cab AC fitment during the Month of May'24. This is the 4<sup>th</sup> Loco on which retro fitment of Cab AC has been done by POH Shop KGPW during FY 24-25.

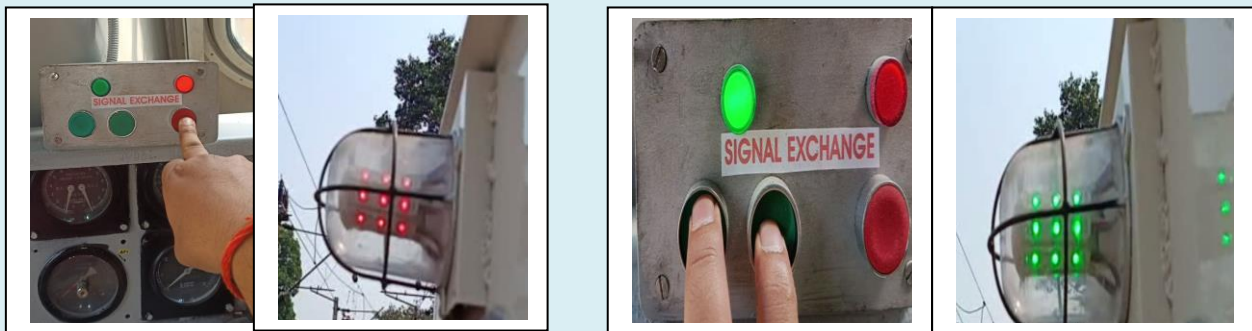
#### **22. Provision of Signal Exchange Light by KGPW POH Shop:**

After provision of air conditioning in loco cabs, it will be very inconvenient to Loco Pilots (LP)/Assistant Loco Pilots (ALP) in exchanging the flags (Red/Green) signals with station staff due to frequent opening of cab doors/windows for exchanging the signals. Therefore, provision of exchanging of signals through LED light has been provided in

22855/WAP4/SRC during the month of May'24. These lamps shall be operated by push buttons provided on the driving desk.

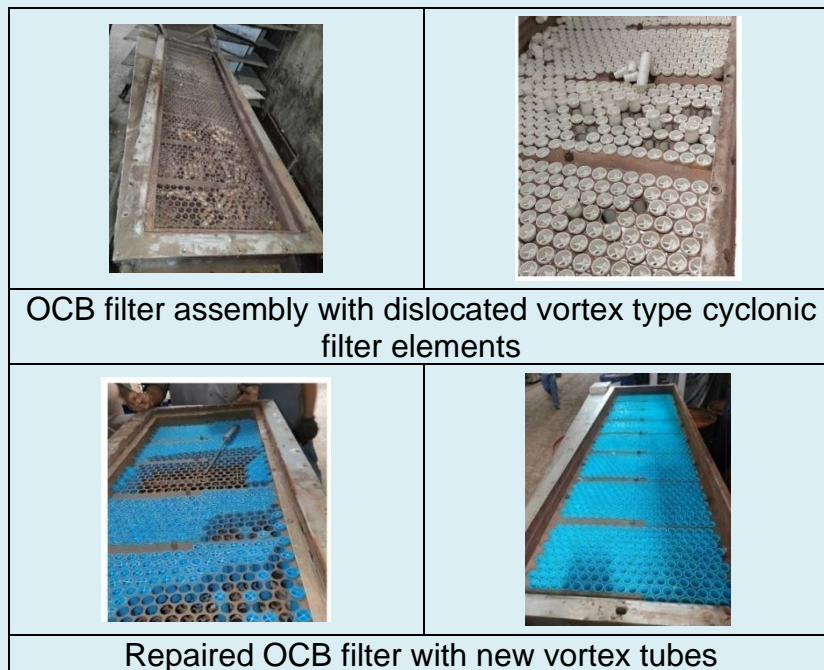
### 24. 3-phase loco filter repairing by procuring new Vortex by ELS/TATE:

Maintenance of Oil Cooling Blower (OCB), Machine Room Blower (MRB) and Traction Motor Blower (TMB) filters of 3- phase Electric Locomotives plays vital role in loco operation. Proper cleaning of cyclonic filters of these blowers helps in improving reliability and temperature control and thus avoids cases of equipment temperature going high. Detailed procedures for maintenance of filter of 3-phase locos (OCB, MRB and TMB) has already been issued by RDSO vide SPECIAL MAINTENANCE INSTRUCTION NO. RDSO/2016/EL/SMI/0286(REV.'0'), Dated 09.06.2016.

During maintenance of these filters, dislocation and shifting inwards/outwards of vortex type cyclonic filter elements provided in filter assembly is being observed by the shed. Shed is replacing the filter assembly having this kind of defects to improve the cooling system of loco. **In place of complete replacement of filter assembly, shed has started repairing of these filter assemblies by replacing the defective vortex tube only with new vortex tube. Non-stock procurement of new vortex tube was done from Silver Line Industrial Incorporation/New Delhi as per CLW drawing no. 1209.11.135.121 Rev-4. It has significantly reduced the replacement cost of complete filter assembly.** Shed has repaired 02 nos of OCB filter assembly by replacing complete vortex tubes with new one during the month and will be provided in loco for performance monitoring. **Saving cost per loco after 100% replacement of vortex tube in MRB, TMB & OCB filter = Rs. 334529.12.**

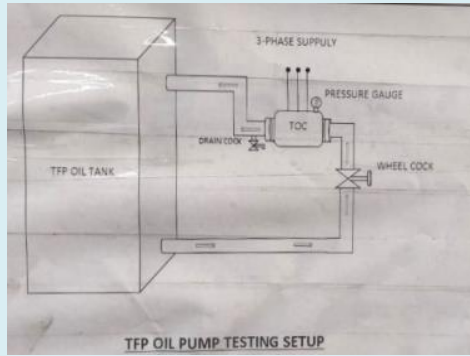
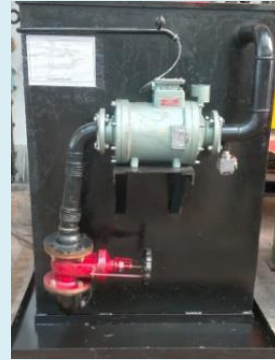
## 25. TFP Oil Pump Testing Setup by ELS/ROUE:

Earlier overhauled TOC motors were directly fitted in loco and if any abnormality was observed then complete TOC motor had to be removed again from loco which was causing loss of man power and time.

To overcome this issue TOC motor testing facilities is fabricated at shed floor where TOC motor can be tested after repair or overhauling and then it can be fitted in loco.

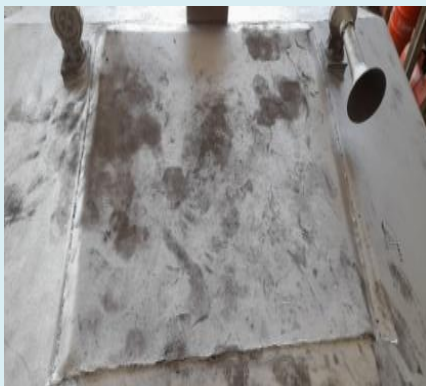
Loco with AC-Dummy Plate

During June-2024, after cutting AC dummy plate Cab-AC provided in Loco No.- 32620 by shed staff. This has been done by ELS/BKSC for the first time.

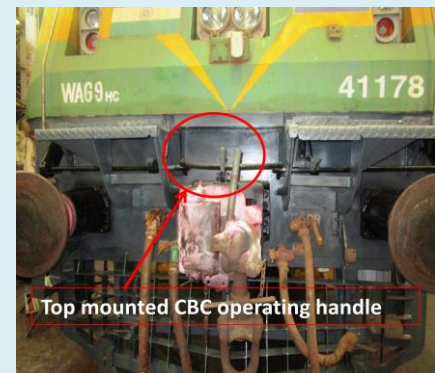
28. **Provision of Top Operated CBC operating handle by ELS/BNDL:**

With the provision of “Top mounted CBC operating handle”, the Crew and Station staff have the flexibility to couple or uncouple the loco with wagon from either side. The modification is being carried out by departmental staff of ELS/BNDL & Contract welders. During Jun’24 10 locomotives have been modified & so far total 101 locomotives have been provided with Top mounted CBC operating handle.

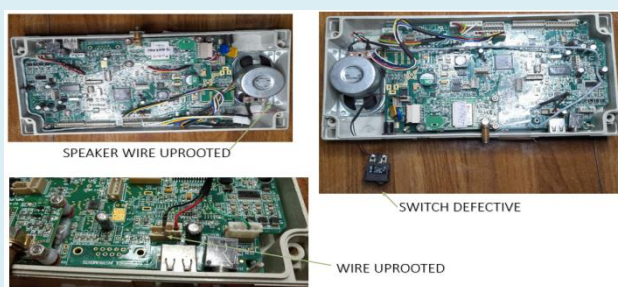
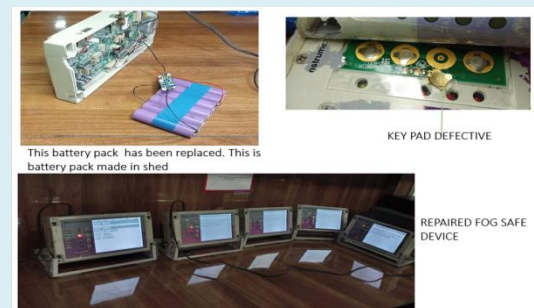
29. **Repair of Fog Safe Device by ELS/BKSE:**

ELS/BKSC has started repair of defective Fog Safe Device. Several types of problem are found in the defective FSD like dry soldering, display not working; switch defective, battery pack defective. All these are being repaired at shed and till now shed has repaired 11 nos. of defective FSD device.

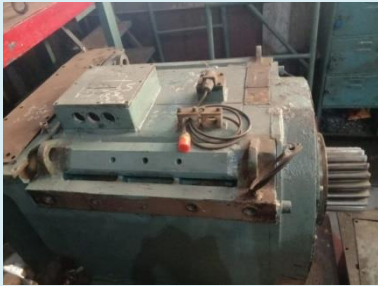
30. **ELS/TATE** has started provision of sensor coupler cover in Speed & Temperature sensor of Traction motor to avoid dust ingress inside and tips cover in Speed sensor of Traction motor to avoid hitting marks while kept in shed floor as healthy spare. It will help further avoiding of TM temperature & speed sensors transient failures. Non-stock procurement of Sensor coupler cover and tips cover (1000 nos. each) was done from Bhawani Enterprises/Jamshedpur as per ELS/TATA drawing no. TATA/RS/MISC/13/6.

TM speed & temperature sensor with cover provided avoids hitting marks and dust ingress

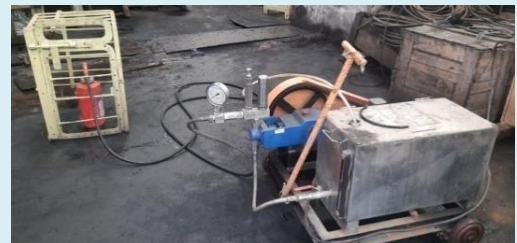
31. **Hydraulic test bench for testing of fire extinguisher by DLS/BNDX:**

DLS/BNDX has been developed Hydraulic Test bench for testing of fire extinguisher in-house. It is used for checking of leakage of cylinder and overall strength, and also to ensure the safety and effectiveness of a pressurized fire extinguisher before re-filling of fire extinguisher.

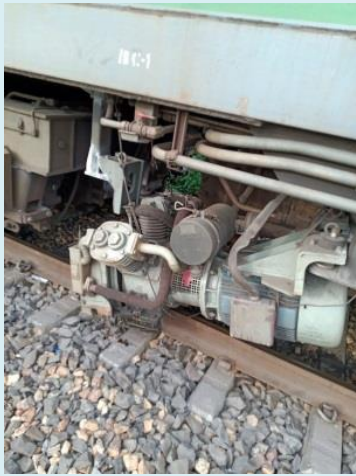
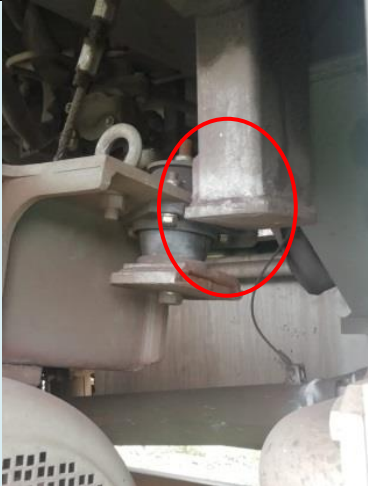
Loco no. 31429 while working Train no. N/Box/E, Compressor-1 was fallen and touching with rail on 06/07/2023	Breakage of compressor mounting leg motor end of loco no. 31624 on 09/07/2019

**Fact:** In three phase locomotives there are 02 Nos. of compressors which are under slung type and suspended from three legs. It is witnessed that compressor falls due to breakage of legs as well as breakage of part of compressor. RDSO has issue SMI 0242\_Rev-3 for maintenance of compressor to avoid falling down.

**But observations of ELS/TATE are different.** In one case of CP leg broken the safety sling had carried out the load of compressor and prevented it to fall on track (Loco no. 31624). In another case, compressor was hanging and grounded (Loco no. 31429). Safety sling was sheared off badly with multiple rubbing marks on it. It was realized that at first safety sling holds the weight of compressor in case of breakage of leg and compressor rest on sling tightly. Compressors will continue to run/stop as their duty cycle. Safety sling of compressor is facing strong rubbing due to reciprocating vibration on run. As a consequence of few run cycles, damaged safety sling gets completely cut off due to weight of compressor and compressor falls further.

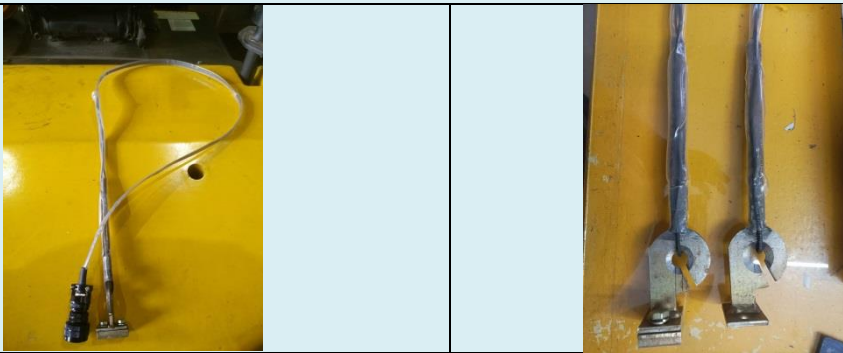
**Scheme:** Two CP DDS units are installed at back side of ALP in both loco cabs. It consists of one green and red LED with one buzzer for each compressor. One separate coupler arrangement is fixed on each compressor which breaks circuit at the instant of compressor dropping. This coupler arrangements are integrated with both CP DDS provided in cab. Breakage of circuit triggers the CP DDS to flash red LED and an audio indication.

Coupler arrangement fixed on each compressor which breaks circuit at the instant of compressor dropping	CP DDS units installed at back side of ALP in both loco cabs

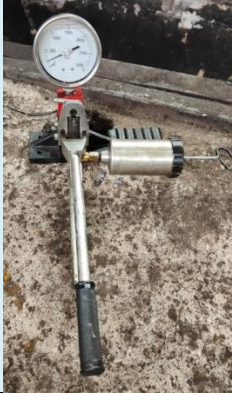
ELS/TATA has made Zig for on line pinion removing from Traction motor of 3-phase locomotives. For this purpose two oil injector pumps are used. These pumps are connected in the oil ejector holes of the pinion. Both pumps are operated simultaneously and oil pressure of approximately 1500-2000 Bar is injected in the pinion. Then the injected oil pressure pushes the pinion outside and thus pinion is removed from the shaft.

<p>Oil injector pump</p>	<p>Oil ejector holes of pinion</p>

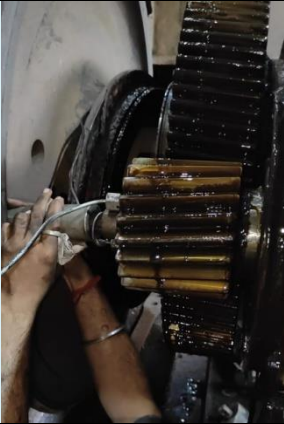
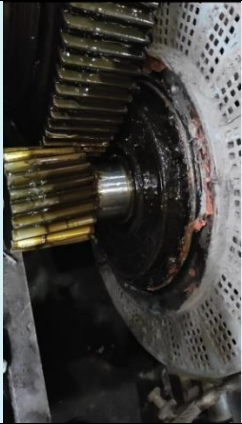
<p>Both pumps are operated simultaneously and oil pressure of approximately 1500-2000 Bar is injected in the pinion.</p>	<p>Injected oil pressure pushes the pinion outside and thus pinion is removed from the shaft.</p>

By this jig pinion of TM will be removed easily on line and its rotor as well as pinion can be reused. It will reduce downtime of locomotives and save manpower.

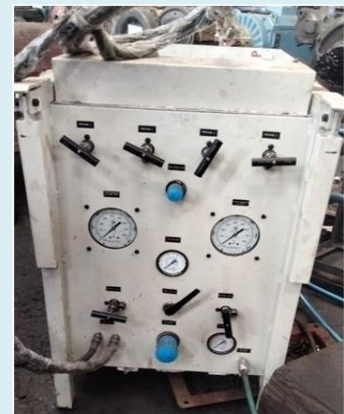
34. **Installation of new Portable High pressure Pinion mounting and extraction machine for 3-phase traction Motors by POH/KGP:**

One no. new Portable hand operated hydraulic High pressure Pinion mounting and extraction machine of Make M/s Krijan for 3-phase traction Motors has been commissioned in ERS-POH. It will be utilized to remove and install the pinion on the traction motor of a locomotive. It will reduce the time required for dismounting and mounting the pinion. It can also lower the chance of damage to the pinion during installation improving reliability.

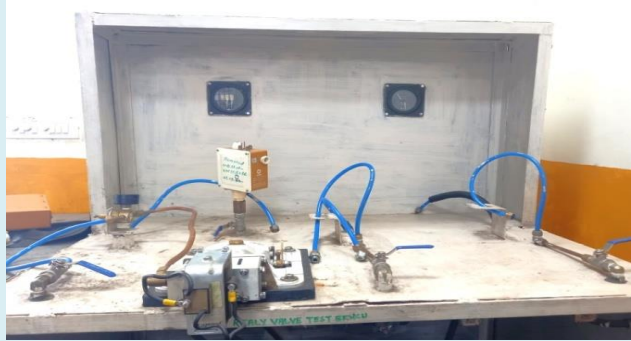
35. **VCB's Relay valve and QPDJ test setup by ELS/ROUE:**

ELS/ROU has developed an in-house setup for testing the VCB's relay valve and QPDJ. Previously, the QPDJ setting and relay valve testing were conducted only after the components were installed on the VCB.

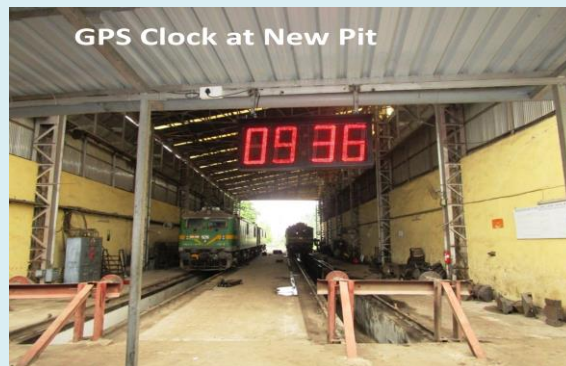
36. **Installation of GPS Clock by ELS/BNDL:**

In an attempt to Synchronize/consistency of Real time among the SPM, VCU, CVVRS, DPWCS & CCB unit equipped in electric locomotives, 2 Nos. of GPS Clock have been installed by ELS/BNDL (at old Pit line no.2 & new pit PPO end). This will help in setting time during inspection and un-schedule repair.

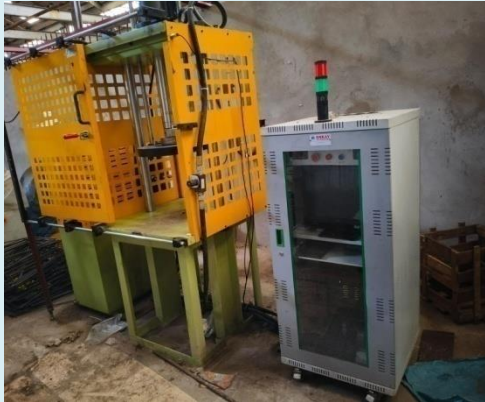
37. **Installation of Hydraulic Spring Testing Machine by ERS/POH/KGP:**

digital Load indicator and length measurement device. It is equipped with data retrievable and storage unit.

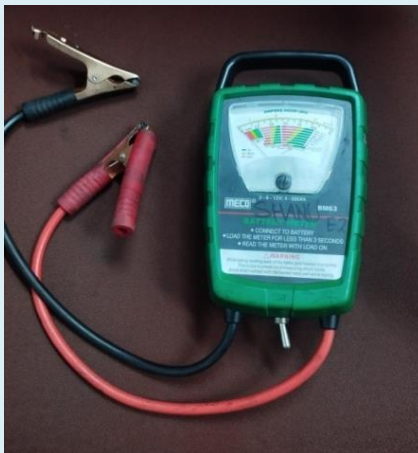
### 38. **Battery Capacity Tester by ELS/KGPE:**

Checking of capacity of batteries of locomotives without removing them, with the help of battery AH Meter has been introduced for assessing the condition of the batteries by ELS/KGPE. The batteries in battery bench are also being checked. This will help in identifying weak and defective batteries and will in turn improve loco reliability.

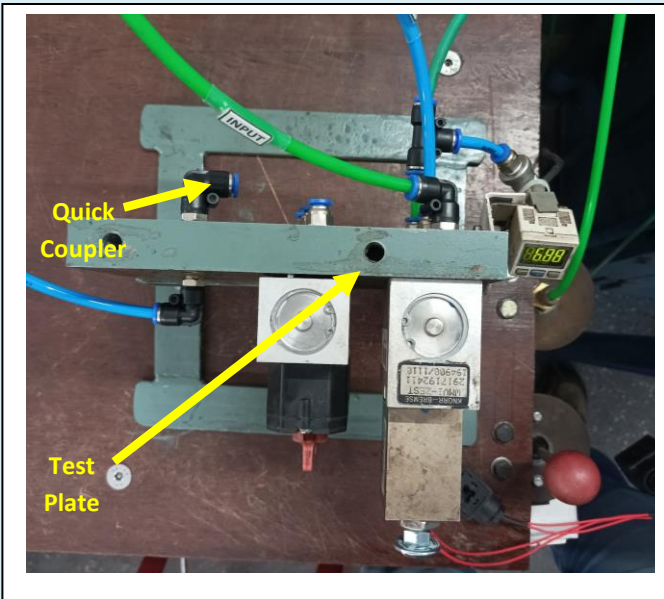
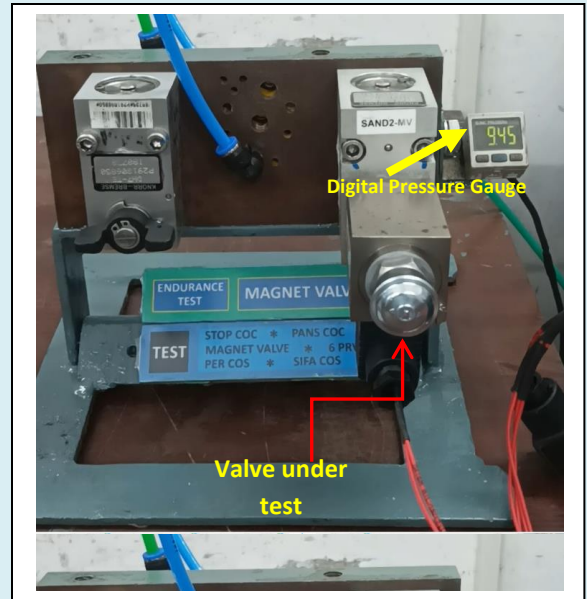
- It is a portable, compact and table top arrangement. It can be used at convenient place and manages space constraints.
- Quick couplers are provided here for pneumatic connection. It is very easy to connect and disconnect the pneumatic port by which different valves are being tested with changing connection quickly. It yields more output in less time.
- Highly precious digital pressure gauge is used for correct calibration of valves.
- Complete exhaust of air from stop cock through energised magnet valve was checked in loco. Magnet valve is being checked with this arrangement.
- Endurance test of magnet valve is also conducted by this test setup.

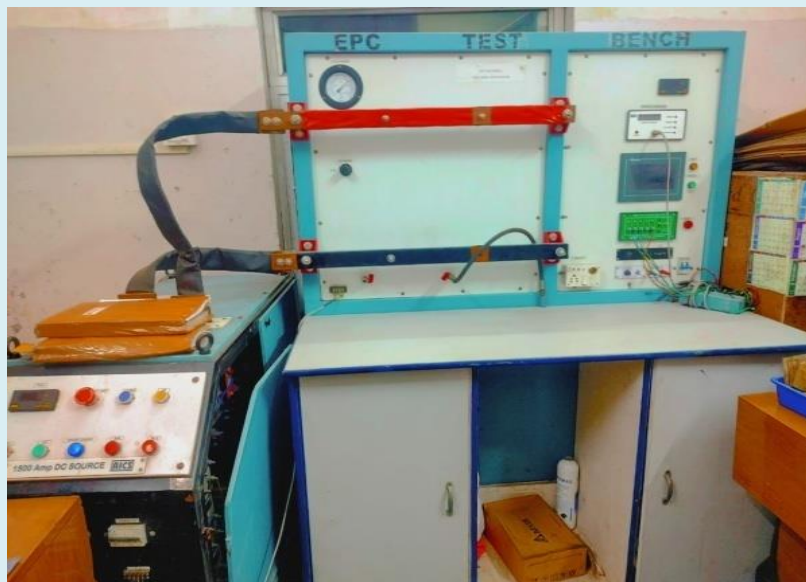
#### 41. Commissioning of EPC Test Bench by ELS/IPTE:

EPC test bench commissioned by ELS/IPTE to improve the reliability of electro pneumatic contactor like Line contactor and shunt contactor during Aug'24.

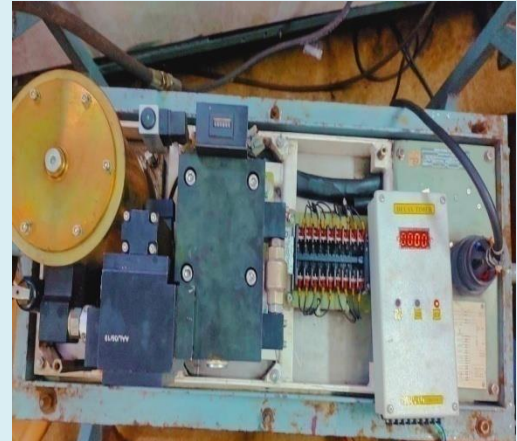
42. **Commissioning of portable Delay Timer TI103C for VCB by ELS/IPTE:**

Portable Delay timer for VCB was commissioned by ELS/IPTE during Aug'24 for checking VCB close time and open time in situ position (inside loco) and on test bench during overhauling.

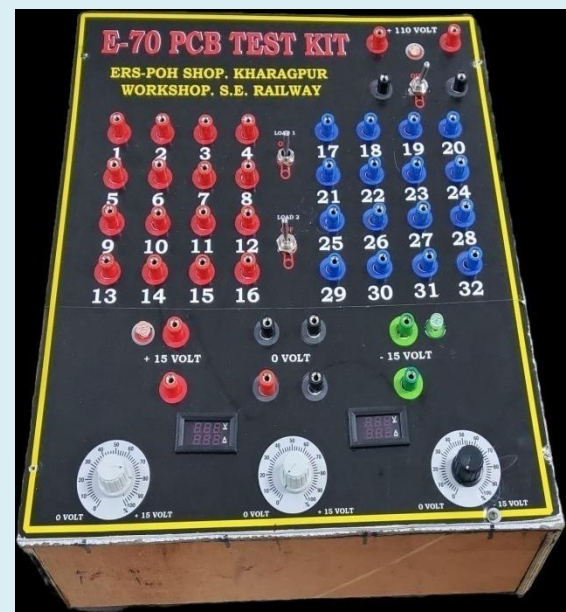
43. **E70 PCB Test Kit by POH/KGP:**

The developed setup will individually test all the cards of E-70 panel. The testing of card includes testing of voltages at different point in the card, observing the status of LEDs in the card, monitoring different cycles of LPO card.

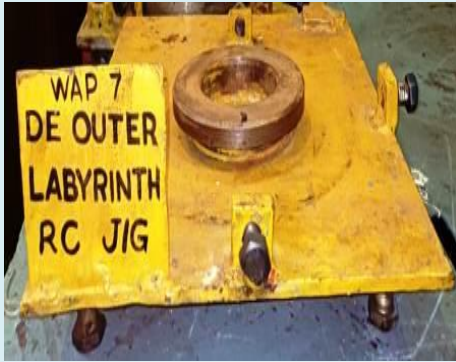
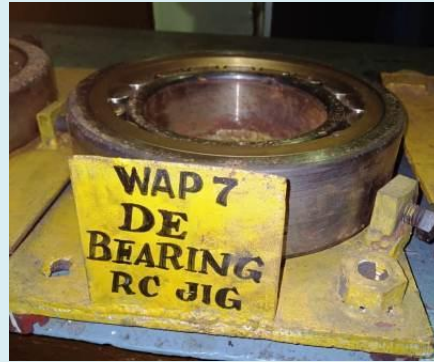
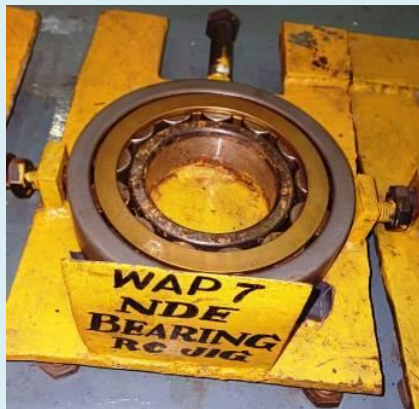
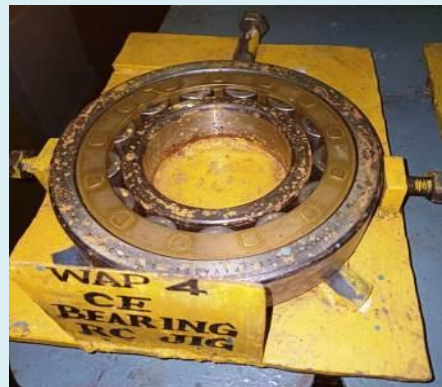
ELS/SRCE has developed Testing Jig for Traction Motor Bearing with available resources in house during Sep'24. This Jig has been used for measuring radial clearance of Bearing and Labyrinth of Traction Motor.

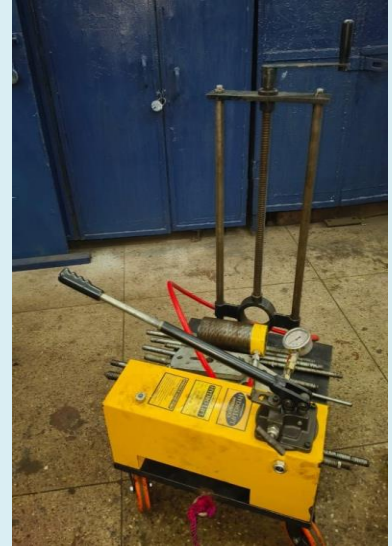
45. **Hydraulic Pusher and Puller arrangements by ERS/POH/KGP:**

The main benefit of hydraulic pullers and pusher arrangements compared to mechanical ones is their capacity to create strong force while requiring less human strength. This characteristic makes them perfect for taking out tough or rusted parts that might not respond well to other methods of removal.

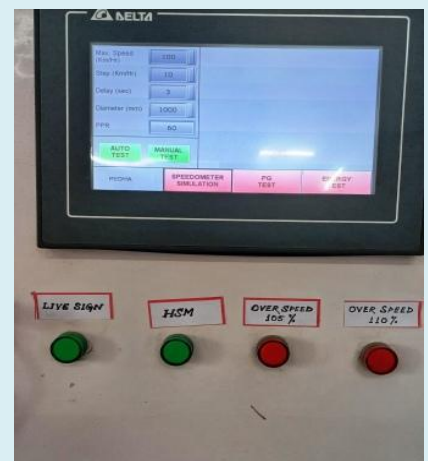
ELS/SRCE has developed an additional feature in existing Test Bench for Speedometer to test / check other parameters which was not available in it initially.

In the beginning, this Test unit was having facility to check / test parameters such as Coasting, Energy, Speed Accuracy and function of Sensor for PG.

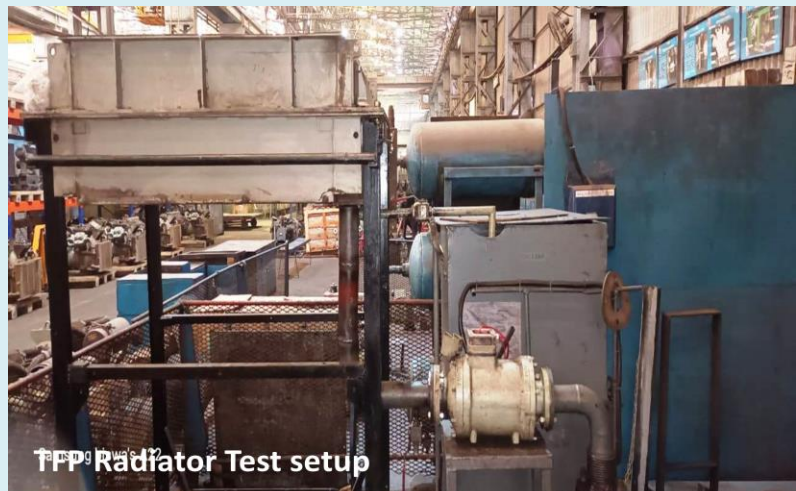
To check the leakage of transformer oil in TFP radiators a radiator testing set-up has been fabricated in-house by departmental staff of ELS/BNDL and connected with TFP Oil pump.

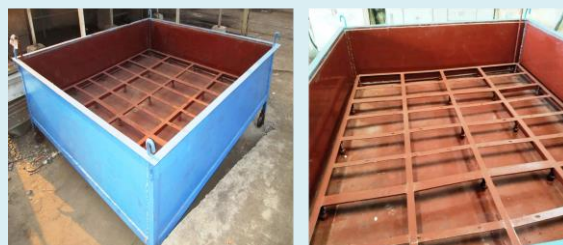
Filter Cleaning Tank

This will eliminates the transportation of filters from new inspection pit no.1 & 2 to line no.5 & 6 of ELS/BNDL.

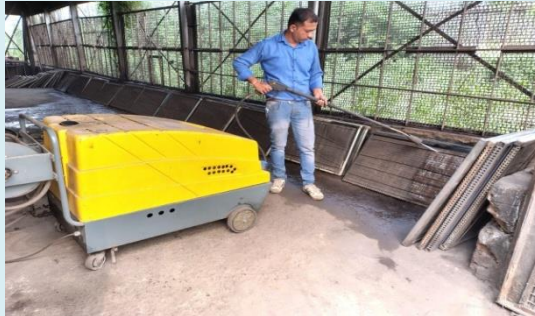
49. Cleaning of Mio Filter has been done with lukewarm water in every schedule with water jet machine by ELS/IPTE during Oct'24.

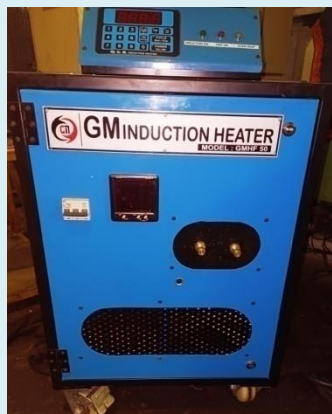
A Seal PE Ring Extracting Machine (Induction Heater for Racer Removing) with Intelligent Micro Controller Based Electronic Control Portable is supplied by M/s. GM Industries, Thane on 07.11.2024 against P.O. No. IG245796101416 Dated 21.10.2024. Testing and commissioning of this machine has been done at ELS/SRCE by M/s. GM Industries on 26.11.2024. Necessary training and demonstration for safe operation of this machine is imparted by representative of M/s. GM Industries.

- Model: GMHF 50
- Machine No : 529
- Manufacturing Month & Year: 10/2024

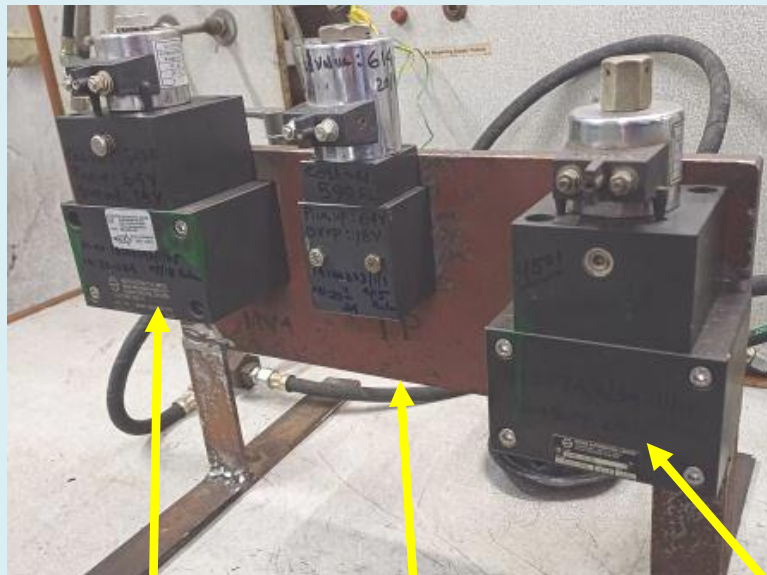
- 1) Coil Value.
- 2) Pick up and drop out voltage.
- 3) Air leakage test.
- 4) Function test (only for IP Valve).

Previously this arrangement was not available at ELS/SRCE. Now, it improves maintenance practice as a result performance of IP and MV4 valves will be better.

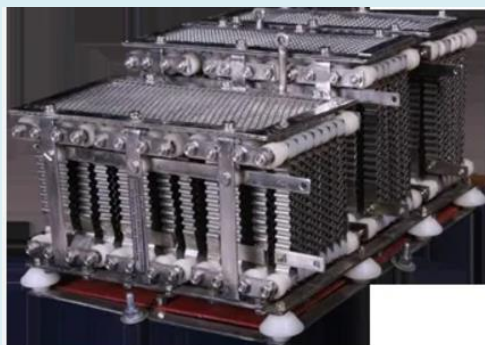
Roof mounted DBR has been converted to vertical DBR in two locomotives (Loco no.28708 / WAG7 / IPTE and 27396 / WAG7 / BNDX during Nov'24.

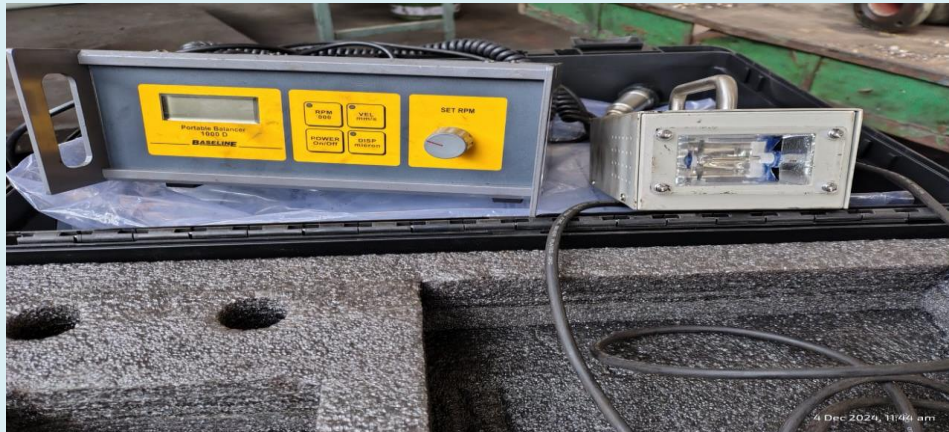
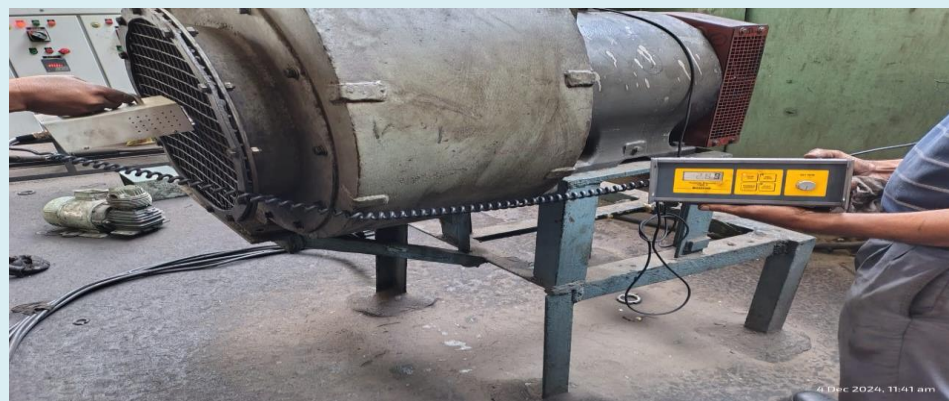
Portable Dynamic balancing machine (Make: Baseline Technologies; SI No: 09244252) was commissioned at IPTE during Nov 24. It is being used for checking of dynamic balancing of Auxiliary motors during overhauling which ensures working of motors without any vibration and improves reliability of motors as well as Locomotives.

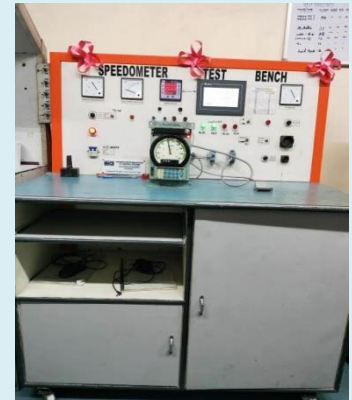
- Calibration of Speed from 0-120 Kmph, 0-150 Kmph & 0-180 Kmph with minimum resolution of 1 KMPH by varying the speed control knob of the test bench.

- Rotation of Loco wheel is simulated by the three-phase induction motor with double ended shaft where speed sensor (PG) can be coupled. Hence; with same test bench can be used for speedometer of any make e.g. AAL, Laxven, Medha and VTL etc.
- Sensor-1 and Sensor-2 testing: Hardware switches will be provided in test bench to run ESMON speedometer on sensor-1 & sensor-2 of PG (Pulse generator) independently.

The test unit provides the facility to speed up to any desired speed and hence over speed trip alarm can be tested easily for AAL, Laxven, Medha and VTL make ESMON type speedometer.

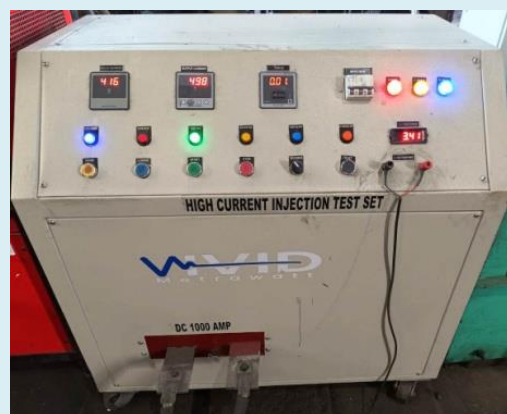
High DC current injection test setup of (Vivid Metrawatt make) has been commissioned at IPTE and POH Shop KGPW during Dec'24. This will help to check susceptibility of brazing joint in stator of Traction motor and thus will reduce the failure and improve the reliability of locomotives.

As per RDSO SMI no. RDSO/2011/EL/SMI/0271 Rev '0', be used for prevention of failure of traction motors in service and detection of bad brazed joints of interconnectors of Main Pole and Commutating Pole coils of Traction motors type HS15250A and TA0659 at the time of overhauling in POH Workshop. It is also used for mili-volt drop test of CTF, Reverser, SL and diodes of RSI panel.

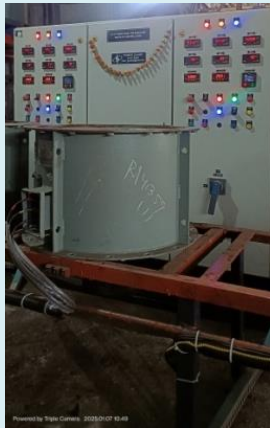
VVVF Drive panel for Auxiliary motor

58. ELS/TATE has procured and commissioned VVVF Drive panel for light load run test of Traction motor and Auxiliary motor of 3-phase locomotives during Dec'24. By this

test panel, shed is doing light load test of 3-phase TM and Auxiliary motor at different frequencies (0-60 Hz for TM and 0-50 Hz for Aux. motor) and voltages.

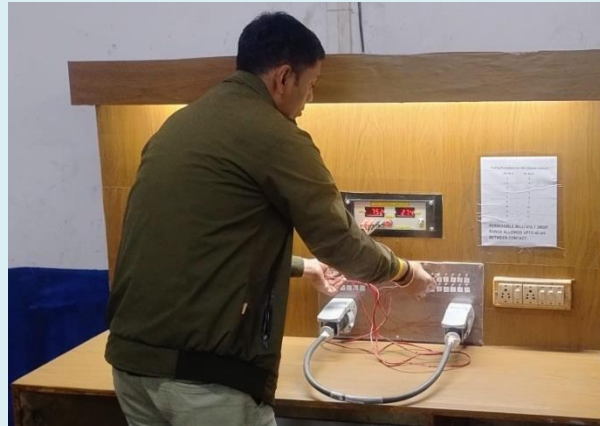
A test bench for checking millivolt drop testing has been made using in-house resources by ELS/BKSE during Jan'25. To ensure healthiness of pin used in MU formation millivolt drop between pin was checked. The permissible millivolt drop limit is 40 mV at 2 Amp supply.

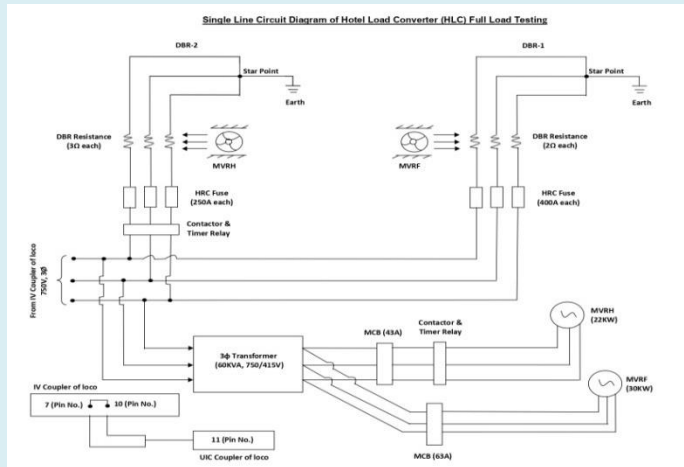
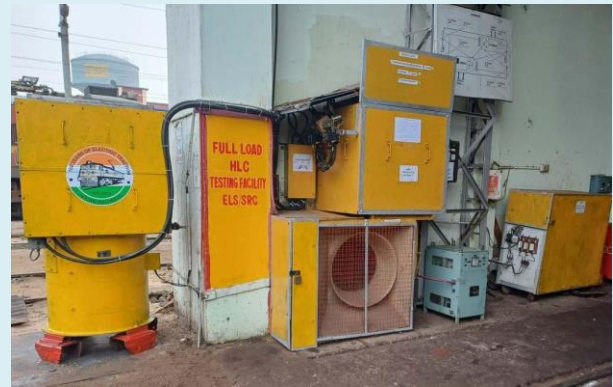
### Hotel Load Converter (HLC) Full Load Testing Unit with Variable Load

Passenger Control Loads as coach lighting, fans, mobile and laptop charging point, air conditioning equipment, pumps, heaters and pantry load such as bottle cooler, water boiler, refrigeration and loads of other equipment namely Battery Charger for emergency light etc. are collectively described as Hotel Load.

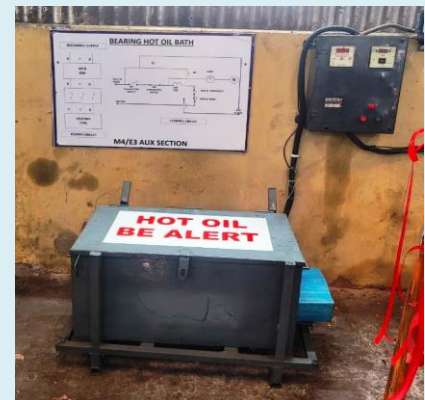
### 63. Oil bath tank by ELS/BNDL:

This will minimize the bearing failures of Auxiliary motors equipped in 3-phase locomotives. Before fitment of bearings on shaft, it was heated by induction heater. For gradual and uniform increase in temperature of bearings, Oil bath heating was adopted.

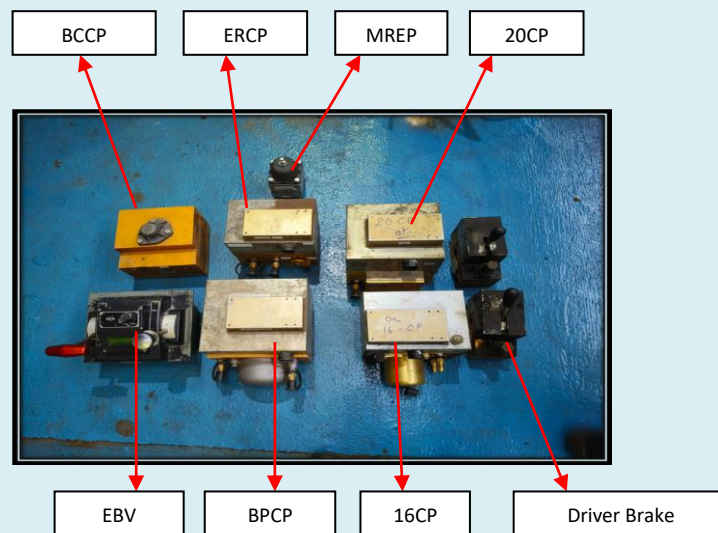
#### 64. Overhauling of Brake Panel by POH/KGP:

- BCCP: Brake Cylinder Control Portion.
- ERCP: Equalizing Reservoir Control Portion.
- MREP: Main Reservoir Equalizing Pipe Valve.
- 20CP: 20 Control Portion.
- EBV: Electronic Brake Valve.
- BPCP: Brake Pipe Control Portion
- 16CP: 16 Control Portion.
- Driver Brake.

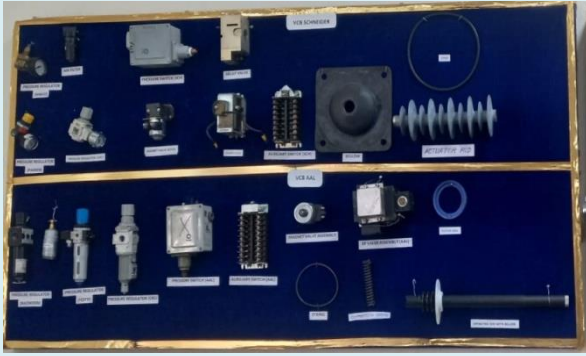
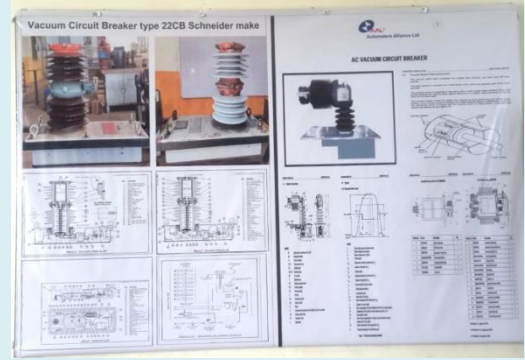
#### 65. VCB's sub-components display and parts nomenclature flex board by ELS/ROUE:

A board for displaying sub-component of Vacuum Circuit Breaker (VCB) and a flex board for its parts **nomenclature** have been mounted on the wall of the VCB overhauling section, providing a clear understanding of the inner structure, mechanical arrangement, and functioning of the VCB. Each part of the VCB is clearly labeled on the flex board for easy identification. It will be utilized as training aid for the staff involved in the maintenance and overhauling of VCBs in the section.

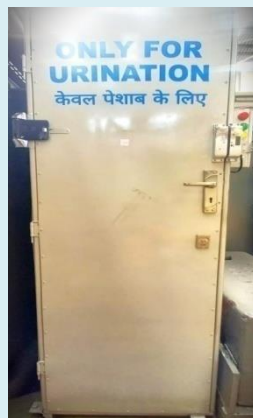
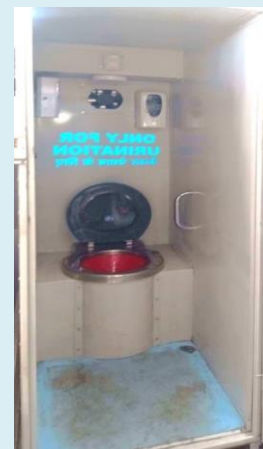
#### 66. Provision of Water less Urinals at ELS/ROUE:

Two locomotives having no. 38900 & 38913 received from CLW for commissioning have been equipped with water less urinals. This is a part of an eco-friendly initiative and to improve the comfort and hygiene of train crew members operating trains over long distances. This water less urinal is designed to be used only when the VCB (Vacuum Circuit Breaker) of the locomotive is in the open condition.

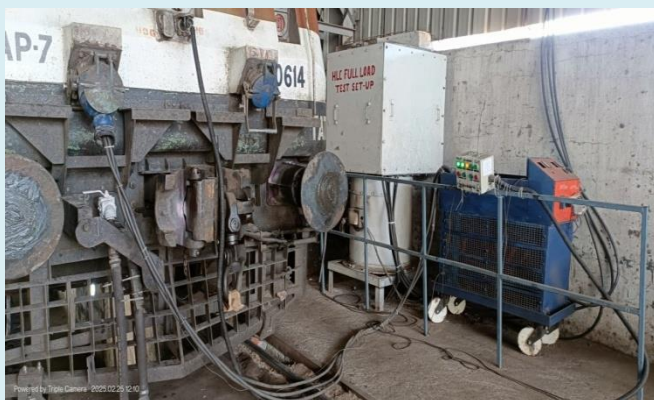
Previously HLC testing was being carried out at around 240 Amps by utilizing a set of DBR with MVRF. In addition to that, the new test setup consists of three leg copper bus-bar submerged in water to increase the additional load of about 150 Amps. By adding up both loads of DBR with MVRF and water load, HLC is now being tested at full rated current of 384 Amps.

HLC full load test set-up consists of three leg copper bus-bar submerged in water

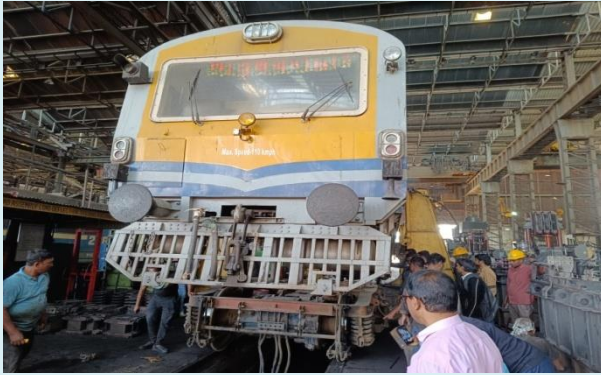
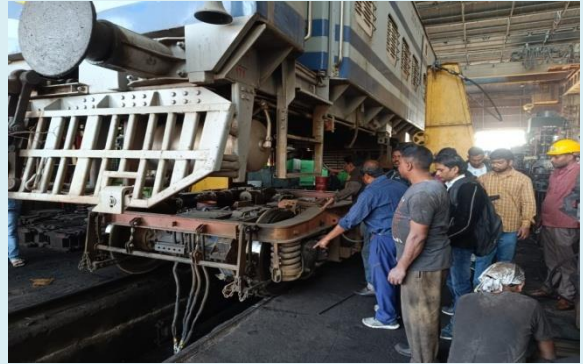
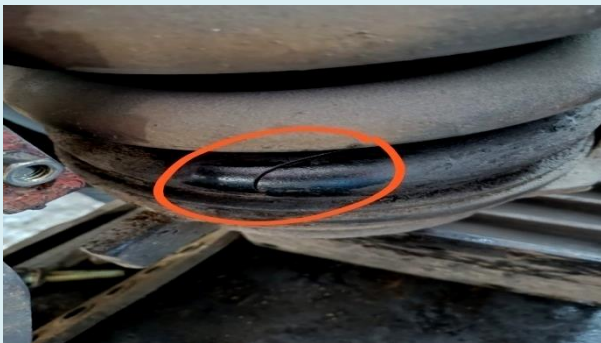
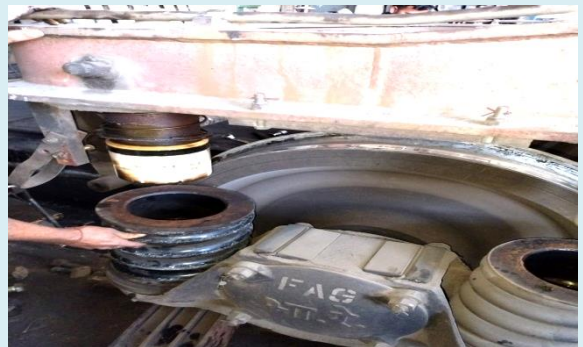
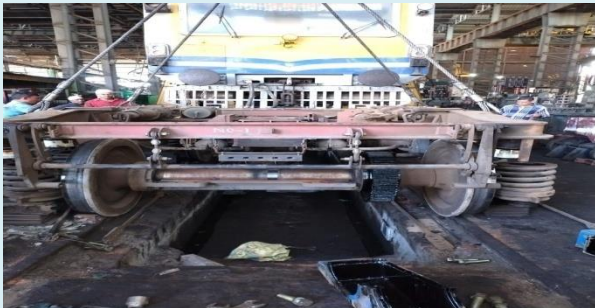
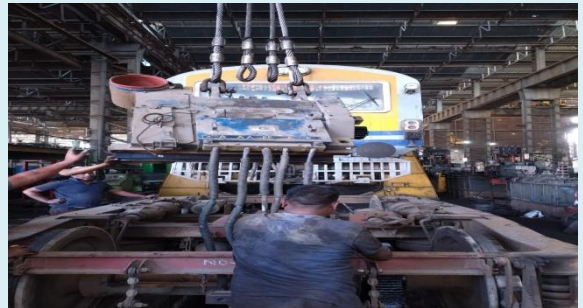
#### 68. Tower Wagon Coil Spring Changing by ELS/IPTE:

Tower Wagon no. DETC-171 (SER-200079) of TRD/BKSC was under breakdown due to coil spring broken of Cab-1 side trolley. Tower wagon was lifted with the help of lifting jack and trolley run out. Traction motors, gear cases etc dismantled, trolley lifted and broken coil spring removed then new coil spring was fitted and all

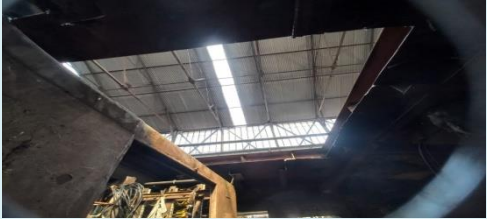
SI No.	Description	Reference Image
1	Cutting of Cab Roof

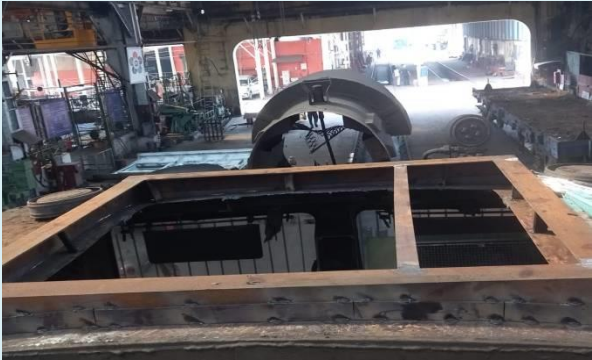
2	<p>The curved shape of the cab roof poses a challenge in the installation of the Cab AC unit, as it requires a flat surface for proper mounting. To address this issue, <b>a flat bar with suitable packing</b> is welded on to the roof, creating a stable and level base for secure installation.</p>

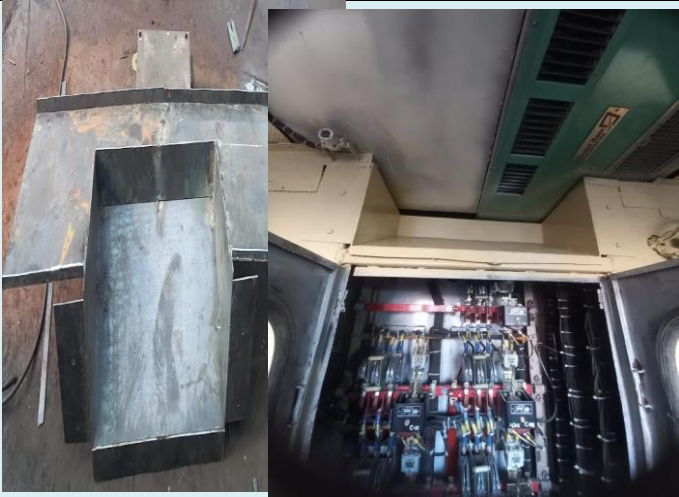
3	<p>In Cab-2, the BD panel, TK panel, and relay panel are located below the AC duct. These panels are fully covered with a plate of an appropriate size and shape, ensuring protection from moisture.</p>

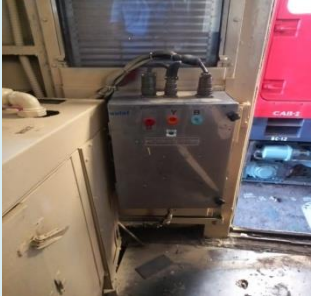
4	The AC control box is fitted to the window shutter assembly.

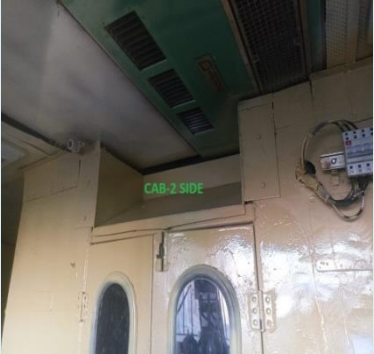
6	CAB-1 and CAB-2 Side image after installation.

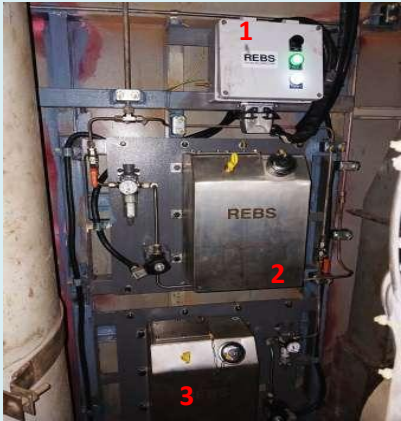
<p>A photograph of the Main Electronic Control Unit (REBS) mounted on a metal frame. It features two lubricant tanks labeled '2' and '3' in red. A red '1' points to the top control panel with a green indicator light.</p>

1) Main Electronic Control Unit. 2) Lubricant Tank for Bogie-1 3) Lubricant Tank for Bogie-2	1) Nozzle	1) Curve Sensor

This modification consists of lubrication system installed with the purpose to reduce the wear and tear of wheel disc.

**In Curvature Path:** Purging will be started just after six second when loco enters in curvature path with speed 5kmph or more and same will be continuing in every six second.

Lubricant discharge: 0.5ml / nozzle in one purge.

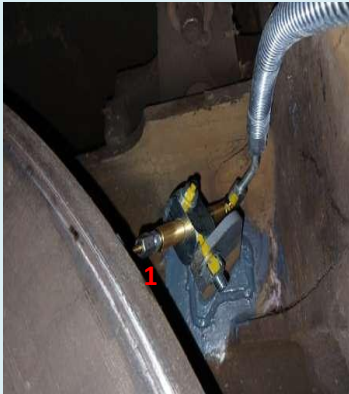
<p>A close-up photograph of a nozzle assembly. A red '1' points to the brass nozzle tip.</p>

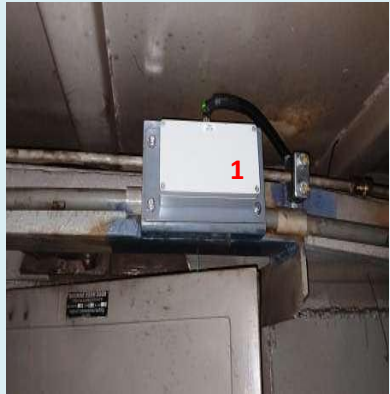
<p>A photograph of a curve sensor mounted on a metal structure. A red '1' points to the sensor unit.</p>

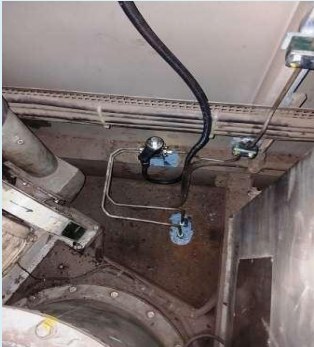
<p>A photograph of a solonoid valve installed in a metal housing. A red '1' points to the valve body.</p>

1) Solonoid Valve	1) Main air cut out cock connecting at RGCP.	1) MCB for electrical supply

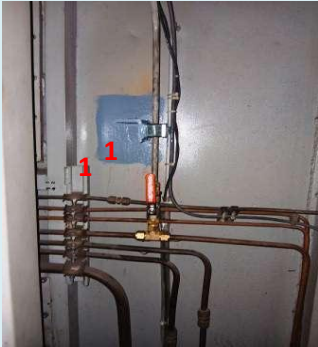
<p>A photograph of a main air cut out cock. A red '1' points to the blue handle.</p>

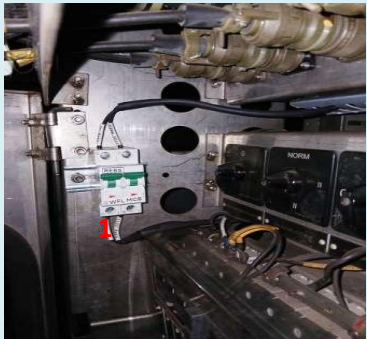
<p>A photograph of an electrical control panel. A red '1' points to a Miniature Circuit Breaker (MCB) switch.</p>
