## **ACHIEVEMENTS OF ELECTRICAL MAINTENANCE WING DURING 2024-25:**

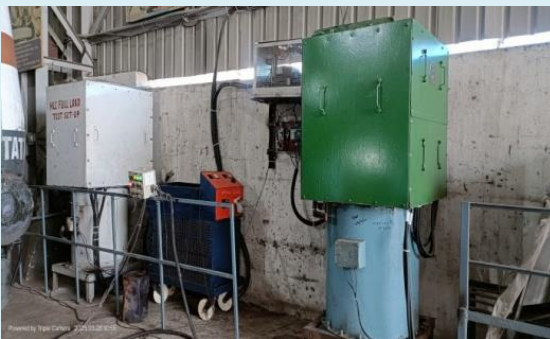
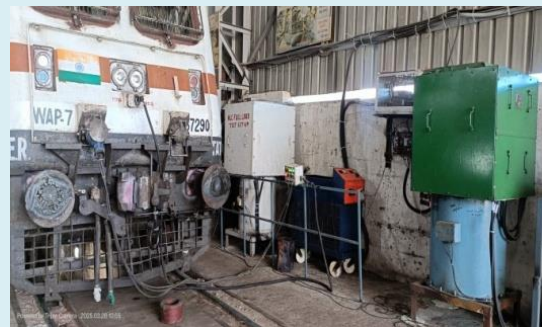
**HLC full load test set-up**

- DBR Resistance Assembly: 02 Nos.
- MVRF: 02 Nos.
- QVRF relay: 02 Nos.
- Female IV Coupler / ZS Coupler coach side: 01 No.
- 60 KVA Step down Transformer (750V, 3-Ph. Into 415V, 3-Ph.): 01 No.
- MCB 63A (output side): 02 Nos.
- Contactor (80 A): 01 No.
- Contactor (500 A): 01 No.
- Voltmeter: 03 Nos.
- Ammeter: 03 Nos.
- LED Lamp: 07 Nos.
- Cable 120 Sq. mm: 45 Metres
- Cable 25 Sq. mm: 30 Metres.

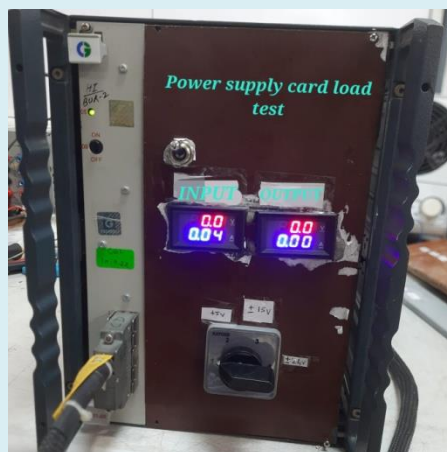
## 72. Power Supply Card Load Test Setup for MICAS/CDAC Type VCU by ERS/POH/KGP:

ERS/POH/KGP has been developed Power supply Card load test set up with in-house effort for MICAS and CDAC type VCU during Mar'25. Power supply card is very vital for the proper functioning of a locomotive as it functions as a power source for control electronics. So testing power supply card becomes necessary as its failure results in complete failure of locomotive. This setup consists of power supply card and various resistors acting as load for different voltage levels of card. The voltage level tested are  $\pm 5\text{V}$  (4 amp),  $\pm 15\text{V}$  (1.5 amp) and  $\pm 24\text{V}$  (2 amp). Testing the power supply card

beforehand increases the reliability of the card during operation, which results in fewer failures and thus helps to maintain the punctuality.

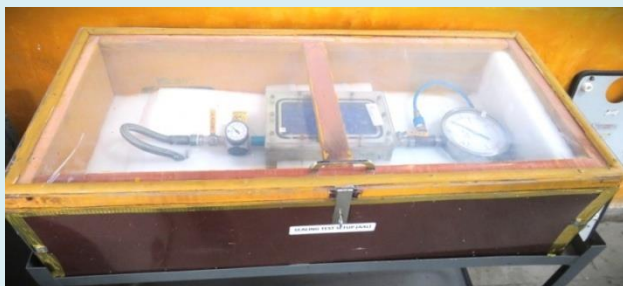
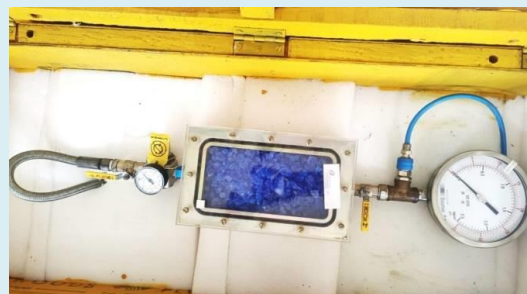
**73. Sealing test for VCB's High Voltage Section by ELS/ROUE:**

A sealing test set-up for VCB's H.T section has been procured from M/s AAL during Mar'25. This test set-up helps to identify any leakage in the VCB's high voltage section during overhauling by applying pressure of 0.8 kg/cm<sup>2</sup> for 30 mins. The sealing test is suitable for both M/s AAL and M/s BT make VCBs.

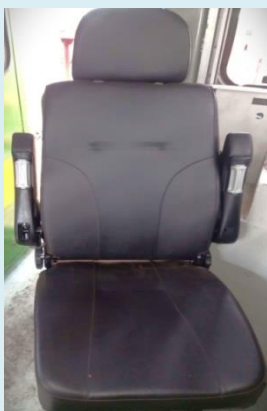
Four new locomotives (38900, 38907, 38891 & 38913) received from CLW for commissioning are equipped with a newly designed driver seat of M/s AB Industries make. This modified driver seat is crafted to provide support during long periods of sitting, featuring soft cushioning for added comfort for the train crew members. Additionally, the chair includes adjustable height, automatic swivel movement, adjustable arm and hand rest, helping to maintain proper alignment, reduce strain and enhance focus.

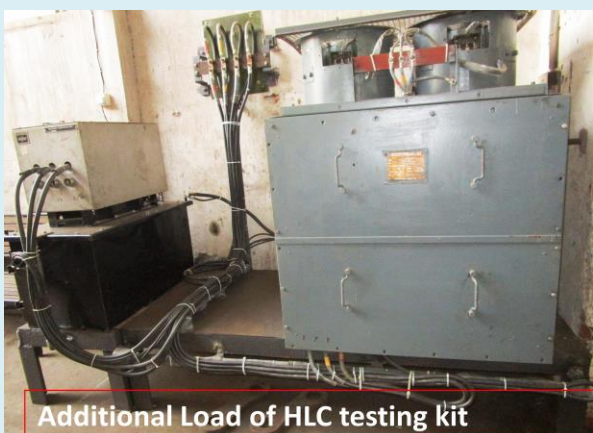
Additional Load of HLC testing kit

75. For testing the Hotel Load Converter at full load, the assembled Hotel Load Converter test bench (312 kVA) has been upgraded to 450 kVA by adding 2<sup>nd</sup> unit of 150 kVA by ELS/BNDL during Mar'25.

Now full load testing of both Hotel Load Converters along with phase sequence can be accomplished within an hour.

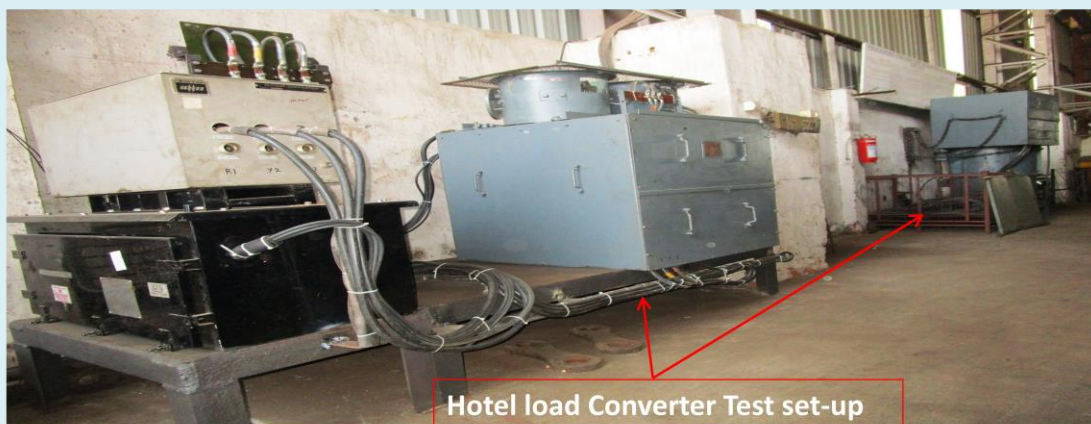
Hotel load Converter Test set-up

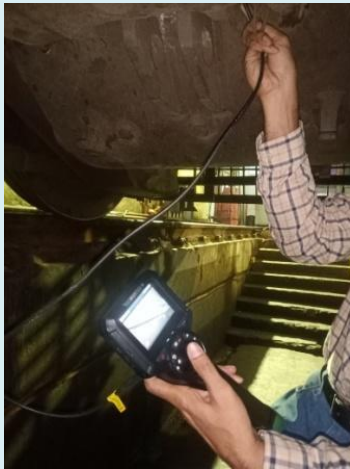
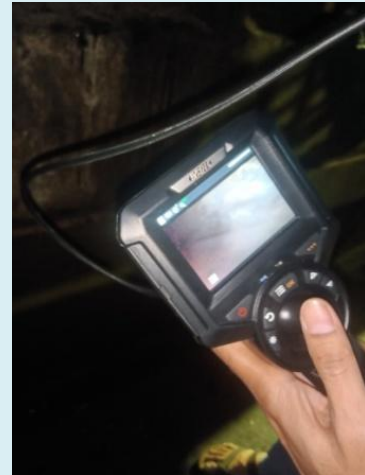
A Video Bore Scope is being started to use in ELS/SRCE with the purpose of checking the inaccessible location of electric locomotives to avoid failure.

During loco maintenance it is observed that certain inaccessible locations need to be checked visually for discrepancies as detection of cracks at visually unreachable locations in under frame, cable faults / cuts at the backside / inside of panels or below footplates, flashing, ingress of foreign particles / broken parts inside ducts.

Its application started in checking of crackness of TM Nose Liner and Bogie Nose by using Video Bore Scope.

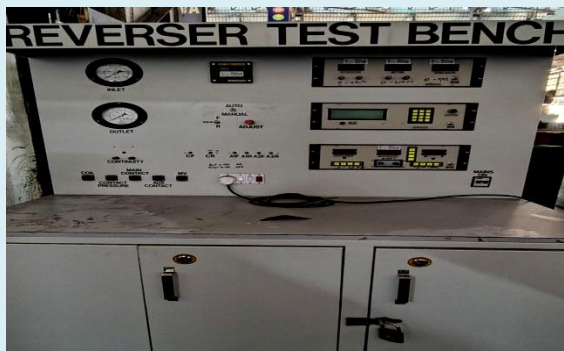
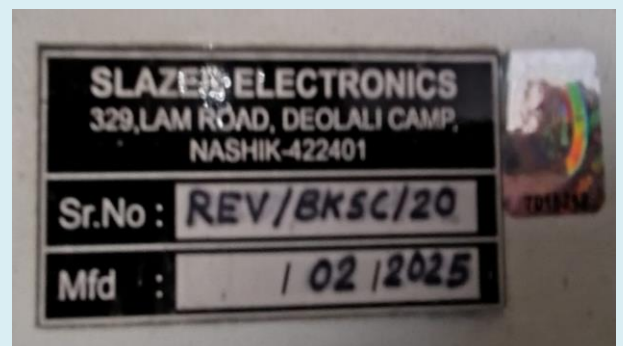
79. **Reverser Test Bench by ELS/IPTE:**

It will be used for testing of drum type Reverser and CTF after overhauling and before fitment in locomotives. It will enhance the reliability of Reverser & CTF and thus reduce the chances of failure.

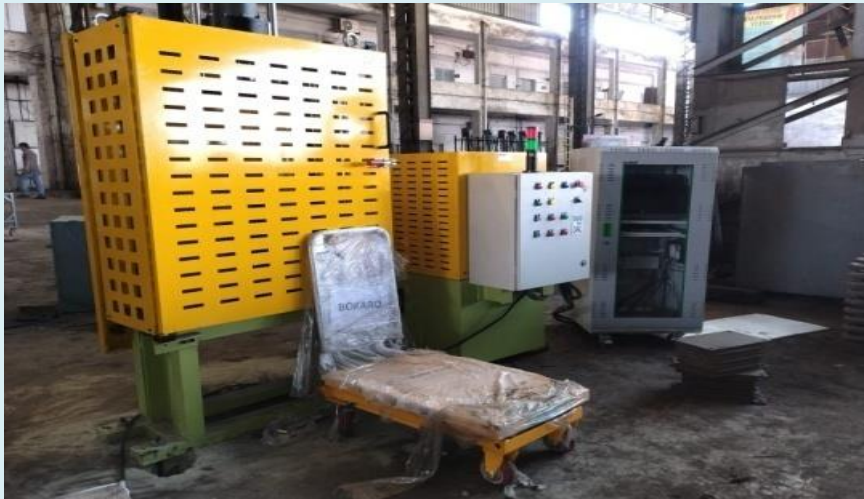
80. **Hydraulic Spring Testing Machine by ELS/IPTE:**

Hydraulic Spring testing machine is commissioned in ELS/IPTE during Mar'25 having make of Enkay Enterprises with Serial number 2025/01, Model no. CSTM-20. This test bench will help in load testing of primary spring (Both inner & outer) of bogie which will further help in sorting and grouping of spring according to its load carrying capacity. Bogie formation with same group of spring ensures uniformly distribution of load on all axles and thus improving reliability.
