Trouble Shooting Guide on Brake Binding in Coaching Stock

IRCAMTECH/2013/Mech/BB/1.0

**Indian Railways
Centre for Advanced Maintenance Technology**

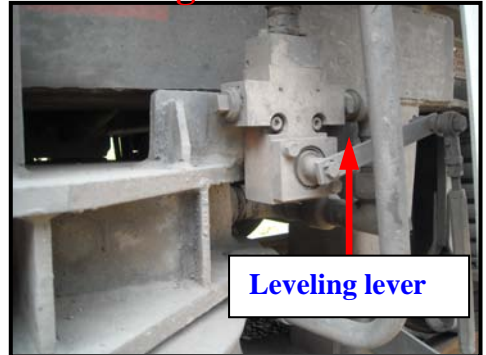
In case of punctured / deflated air bellows, leveling valve lever will be in an inclined position as shown in the figure.

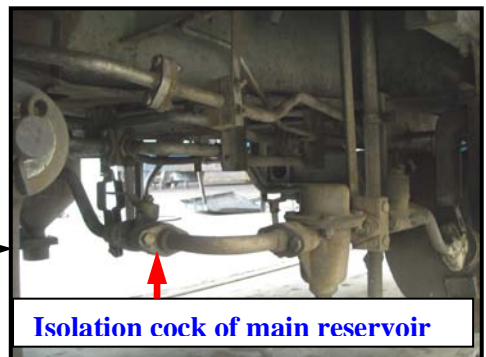
In case of main reservoir of air spring damaged and leaking, close the isolation cock of the main reservoir. Work the train at restricted speed of 60 km/hr up to the next train examination point.

However, in case of leakage from drain cock due to opening of cock, close the drain cock and work the train at prescribed speed after ensuring that there is no leakage in the system.

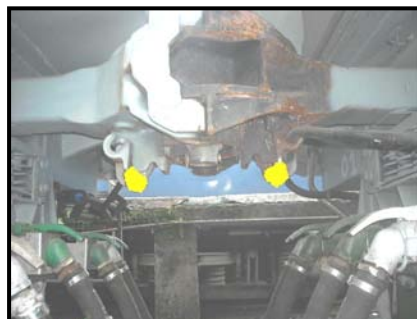
- 1) Bring the coaches near each other at a slow speed and stop the coach at approximately one meter distance of each other.
- 2) Ensure that locking screw is in unlocked position otherwise unlock the operating handle by rotating locking screw anticlockwise with key.
- 3) Lift the operating handle and turn it in clockwise direction (by minimum 90°) to a horizontal position to open the CBC.
- 4) Check alignment and position of coupler centers and attach at approximately 2 to 3 km/hr speed.
- 5) Check position of tell tale device for proper coupling (location of the tell tale is shown in figure).

Tell tale sign should be clear after coupling of loco /coaches as indicated to ensure proper coupling.

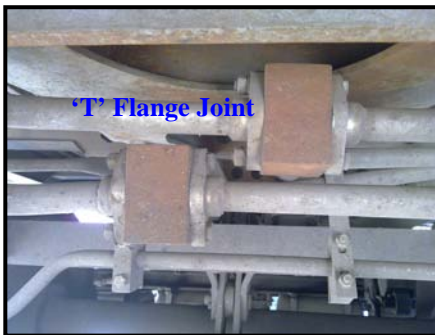
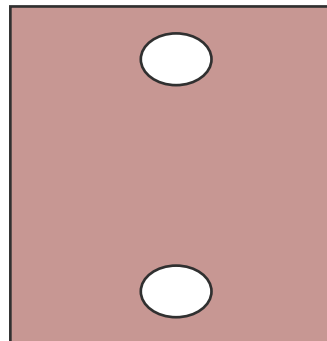
MS Dummy Plate
(98x65x2 mm)

4. Trouble shooting in case of BP-FP cut off angle cock failure on the last coach (Hybrid coach)

1. Close rear Cut off angle cock of adjacent coach of the affected pipe.
2. Loosen and remove the both bolts.
3. Make gap between block and affected angle cock pipe.
4. Insert Dummy plate between block and affected pipe flange.
5. Insert and tighten both bolts.
